National Register of Historic Places Registration Form

1. Name of Property	
historic name Fiddyment Ranch Main Complex	
other names/site number	ation System Number P-31-001223
2. Location	
street & number 4440 Phillip Road	not for publication
city or town Roseville	☐ vicinity
state California code CA county Placer	code 061 zip code 95747

7. Narrative Description

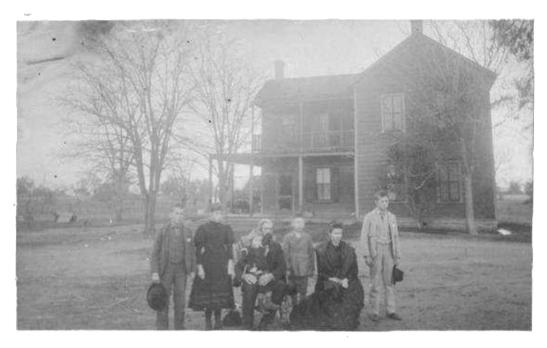
Fiddyment Family in front of main ranch house, ca 1890s. View looking east. (David Fiddyment Collection).

The Fiddyment Ranch main house is a two-story, tongue and groove horizontal board, Neo-classical ranch home. The circa 1879 main house appears to have been renovated twice between 1879 and 1950. These additions reflect the growth of the Fiddyment family, both in prosperity and in size during this time. Walter Fiddyment's father-in-law, Augustus E. bond, a professional brick mason, reportedly built the brick fireplaces at each gable end of the 1879 two-story I-house. A second two-story, cross-gabled addition was made to the north side of the house, probably before 1910, adding two more brick fireplaces. The 1879 to circa 1910 portion of the house is on a brick foundation; this is not discernible from the current exterior of the house.

In 1950, a major renovation was made to the interior and exterior, giving it a Neoclassical façade, adding to the east and west sides of the house, removing the two west side fireplaces/chimneys, and turning the two front, first-story rooms, including a music room and a sitting room, into one large living area. At this time an addition was added to the west side of the house to accommodate an interior staircase leading to the second floor. An original sunporch on the east side of the house was enclosed to create a small kitchen nook. The second floor windows were replaced with casement windows, as were a few windows on the first floor level of the house. Many of the original interior features, however, were kept intact.

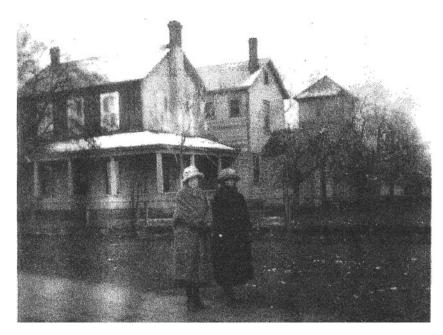
Margorey and Florence Fiddyment in front of main ranch house, winter 1913. View looking northwest. (David Fiddyment Collection).
